FOCUS ON MECHANICAL FAILURES:

MECHANISMS AND DETECTION

Proceedings of the 45th Meeting  
— of the  
Mechanical Failures Prevention Group

Annapolis, Maryland

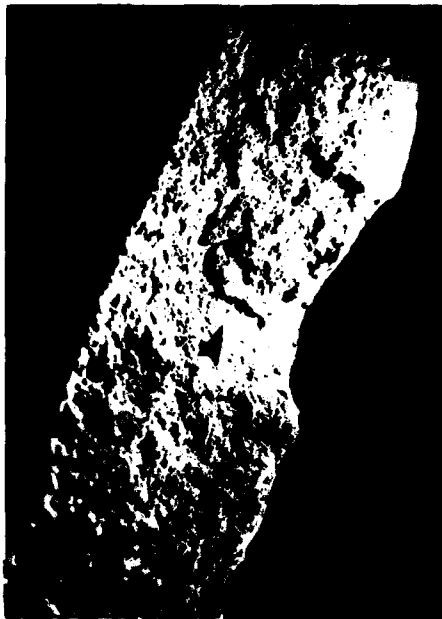
Fig. 2. Aspect of a crack split observed on the surface of a large diameter gray cast iron pipe. The crack propagation direction is indicated by an arrow.

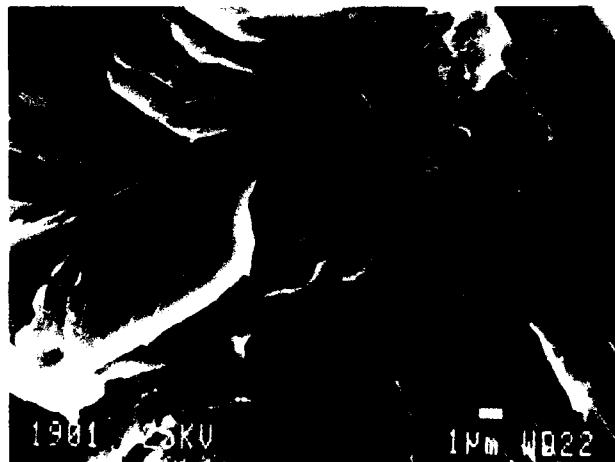
Fig. 6. Typical crack reinitiation sites observed on the fracture surface of a galvanized structural steel bar. Crack reinitiation is situated at the grain boundaries and at times at or near inclusions at these boundaries. Fig. 6a shows an inclusion at the initiation site and a few line-markings near this site.

**Microfractographic features of a hydrogen embrittlement failure:** The first type of microfractographic feature which will be described was found on a part brought in by a student for a laboratory failure analysis case study course. The part which failed corresponds to a mild steel galvanized bar used as a man-hole type rung ladder. The fracture produced three almost semi-circular portions of the fracture surfaces corresponding to slow crack-propagation covered with corrosion product which was difficult to remove. The presence of these cracks resulted in a brittle (cleavage) fracture when a worker accidentally dropped his tool chest on the rung. Cleaning of the fracture surface in a dilute, inhibited HCl solution resulted in the removal of the corrosion product from the freshest portion of the slow crack growth regions. Study of the cleaned regions by scanning electron microscopy showed that the slow crack growth had occurred partly by a cleavage-type fracture and partly by an intergranular fracture, with a very large number of crack reinitiations ahead of the previous crack tip (Figures 6-8). These reinitiations generally were situated at grain boundaries (Figures 6-8) and at times in the vicinity of inclusions at grain boundaries (Figure 6). As well, localized deformation markings were present on the fracture surface in the region of many of the crack reinitiation sites (Figures 6a, 7 and 8). Some of these localized deformation markings appeared to indicate logical intermediate positions of the crack front of these newly initiated crack segments (Figures 7 and 8).

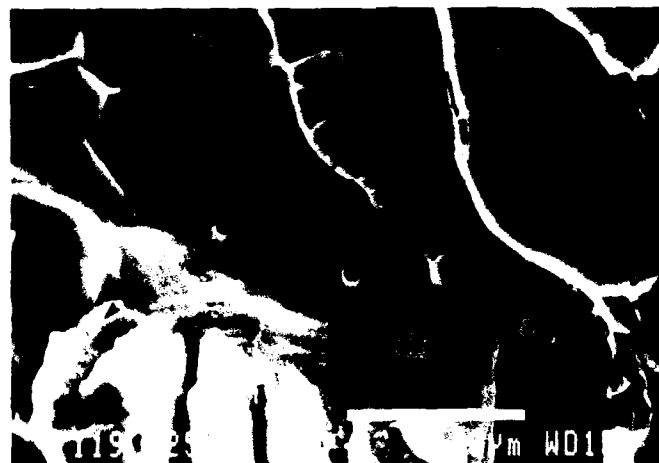
Fig. 8. Localized deformation markings present mainly on a small intergranular portion of the fracture surface in the vicinity of a crack reinitiation site. The aspect of some of these lines, particularly those on the transgranular cleavage facets ahead of the arrow, indicate that they correspond to intermediate crack front positions.

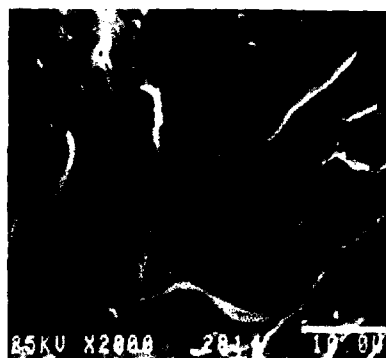
Figure 16 - Fractograph showing slip lines appearing at free surfaces due to torsion

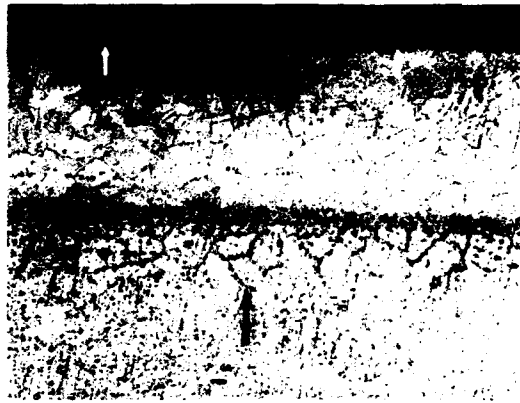
9. Photomicrograph from the cracked area of Figure 2. Area A depicts a layer of chromium oxide, Area B is the duct material, the black arrow is where intergranular corrosion was taking place, and the white arrows is the outer surface. Mag 500X. Valalis Etch

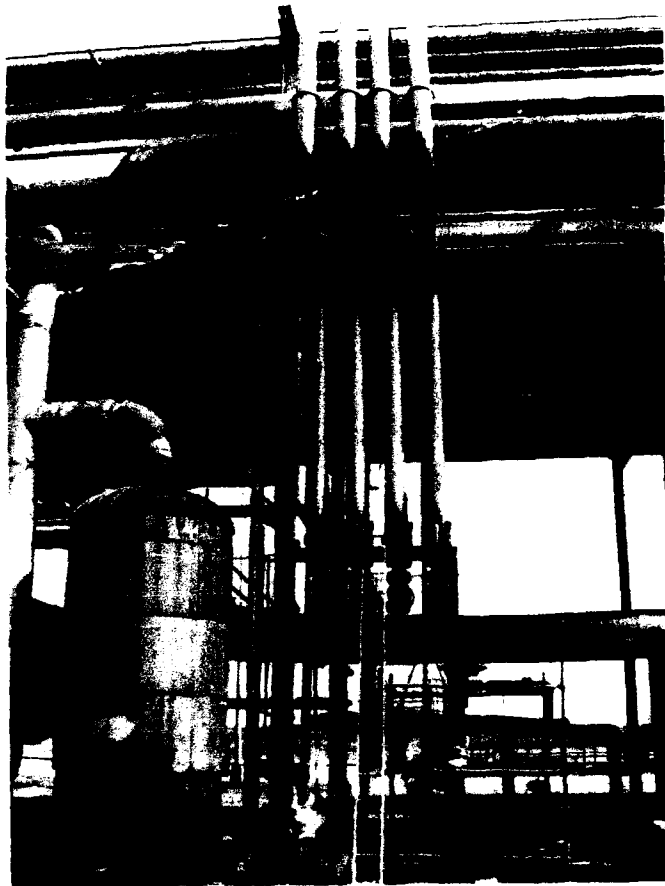
**Photograph 1**

**View Looking East of the  
Four Discharge Pipes**

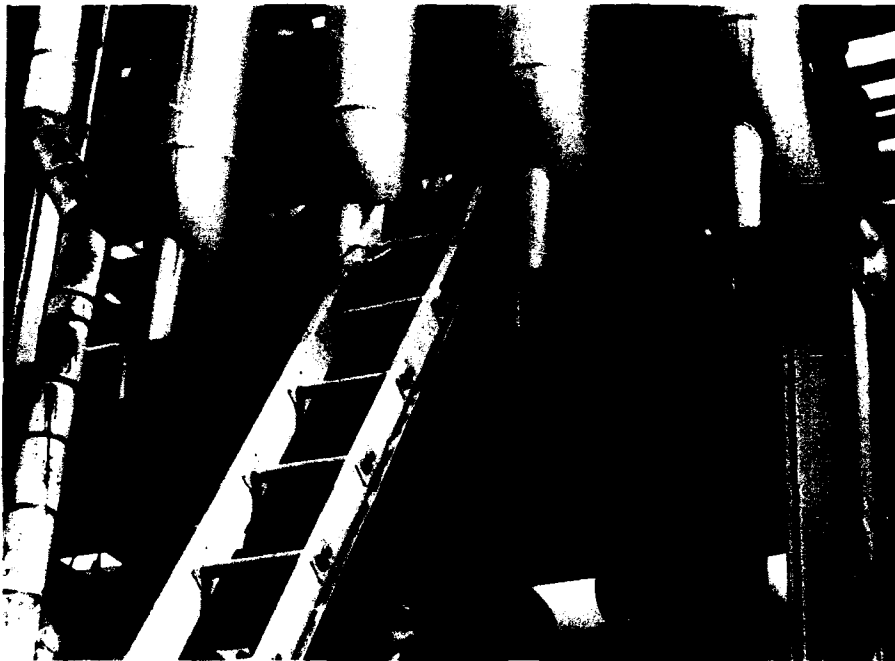
**Photograph 2**

**View Looking East of the Discharge  
Pipes and the Channel Supports**

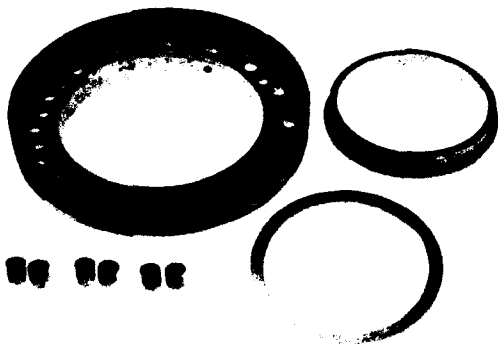
Figure 1 1:4  
Photograph showing a damaged cylindrical-roller-bearing in addition to separate components;  
a) outer-ring; b) inner-ring;  
c) rollers.

The straight-roller-bearing ("A"), shown in figure 1, showed the same damage at the outer-ring, inner-ring and the two cylindrical rollers. The damaged areas found on "A" were about one tenth of a millimeter, orientated in the direction of bearing rotation, and appear as striation lines. SEM-investigation show that the local and periodic damaged areas were craters formed from melting (figure 2).

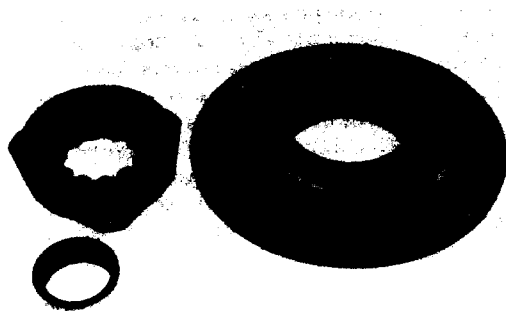
Figure 5 1:2.8  
Damaged cylindrical-roller-bearing "B" and ball-bearing "C";  
a) ball-bearing  
b) cylindrical-roller-bearing

The heat supplied into the bearing parts by electrical current caused microstructural changes which could be immediately recognized. The rapid cooling of the melted material caused a local martensitic solidification and a zone which was not possible to etch. The adjacent heat effected zone shows prior austenite grains which are clearly delineated. Both the different depths of the melted zones and the different structure development observed may have been caused by different high heat/energy-inputs combined with the surface finish. The straight-roller-bearing "B" and the ball-roller-bearing "C" (Figures 5, 6, 7 and 8) had the same appearance as described above for "A".

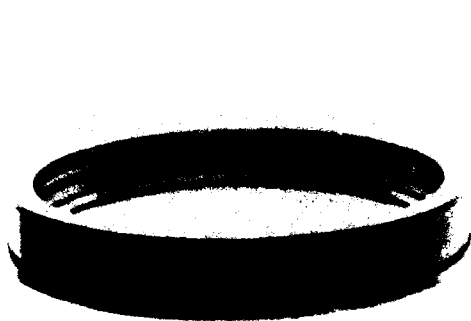
Figure 9 1:2.4  
Photograph of straight-bearing "D";  
outer-ring with damages in the mar-  
ked zones.

Bearing "D" was investigated both visually and with an optical microscope. Damages similar to those found previously were observed (Figures 9, 10, 11 and 12). With the help of a SEM it was possible to show that the damages (see Figures 13 and 14) were not caused by electrical current because the characteristics were totally different. The outer-ring, the separator and the ball were damaged at the surface by the influence of corrosion and secondary damages. Damages caused by adhesive-, cohesive- and tribo-corrosive wear and tear could be differentiated without confusion from damage caused by electro-erosion, in spite of the final condition of the surface following overrolling actions.

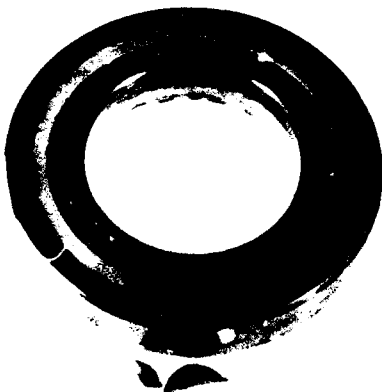
Figure 15 1:2  
General view of the cylindrical-  
roller-bearing "E" with broken  
pieces from the face of the outer-  
ring.

The straight-roller-bearing "E" was damaged at the outer-ring and showed areas along the face and the ball-race where material pieces had been broken off (Figures 15 and 16). The damaged ball-race areas had the same spacing as the rollers around the bearing.

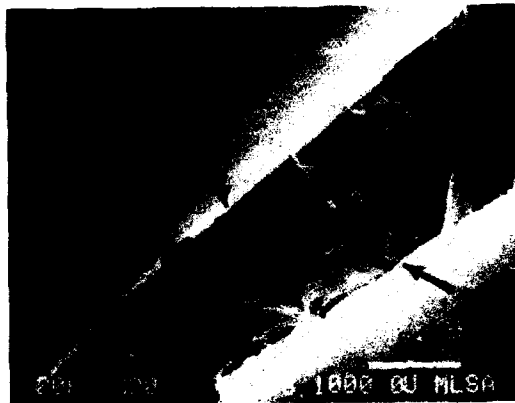
4. Photograph of the fracture face from Blade No. 2. Points 1 (suction side) and 2 (pressure side) depict crack initiation sites. Mag 20X

Figure 4 shows the fracture surface on Blade No. 2 from the failed blisk. Points 1 and 2 in the photograph depict areas where an oxide layer was present. The oxide layer was thicker at Point 2 than at Point 1. Point 1 is on the suction side of the airfoil and Point 2 is on the pressure side. Note that the oxide layer was almost non-existent in the middle of the blade, the area between Points 1 and 2. The location of Point 1 is almost identical to that of the crack initiation point of Blade No. 1. There were indications of abrasive marks at and near Point 1, much like that near Point A of Figure 2. However, no evidence of cyclic loading was found (evidence of cyclic loading might be present but the oxide layer was too thick for the SEM to penetrate in order to obtain an image). Figure 5 is a rotated representation of Point 2 from Figure 4 (photograph of the side of the airfoil). Note the coloration, shown by the arrows, on the airfoil in the middle of the photograph. This coloration was probably caused by excessive dry grinding which burned the surface of the airfoil, confirmed by the presence of the grinding marks in this area. Also, small foreign particles were found to exist in the cracks surrounding the burned area (arrows in Figure 6). An EDS analysis indicated these particles were composed of iron, calcium, sulfur, chromium, potassium, copper, phosphorus, silicon, and chlorine.

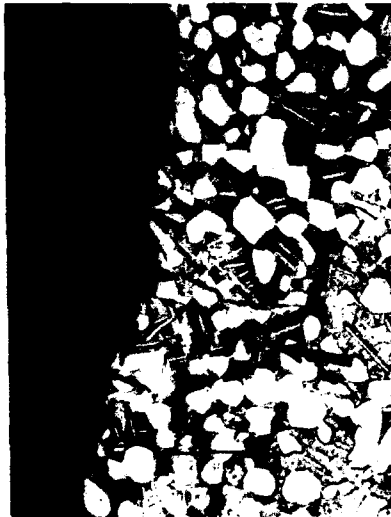
9. Photomicrograph of an area closer to the fracture face than those depicted by Figures 7 and 8. Note the presence of the crack and coloration (shown by the arrows). One per cent HF etch. Mag 1000X
